**Flood Control Project Maintenance  
Levee Inspections**

## Maintenance Issue Types Only, Levee Inspection Report By Mile - Spring 2019

### Reclamation District No. 1601 Twitchell

Waterway	Bank	Unit Miles	Inspection Start/End	Inspector
Unit No. 01 Threemile Slough	Left	2.43	03/28/2019 03/28/2019	David Julian

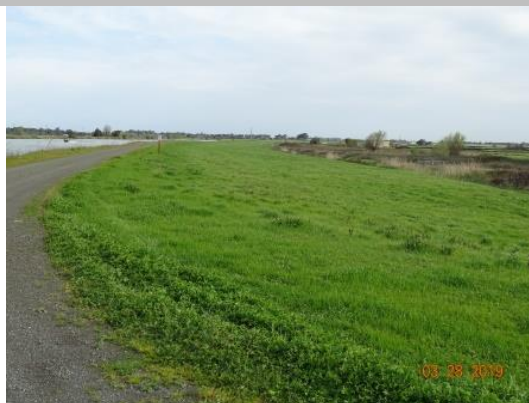
Photo 1 of 1 : SP\_2019\_RD1601\_237\_9\_20190329\_00013.jpg

LM Start	0.01	Rating **	A	Issue No.	9
LM End	2.42	Issue Type +	Ma	Location *	LS
Category	Earthen Levee			GPS Latitude/Longitude	
				Start	End
Item	Vegetation			38.122132 °	38.087735 °
				-121.682590 °	-121.683872 °
DWR ID	DWR_RD1601_01_s_2019_9				
Comment Code					
V1 : Control annual grass and weeds on the levee slopes and easements.					
Inspector Comment					
LMA doing a good job maintaining annual vegetation

View looking upstream at annual vegetation on the landside slope (Spring 2019).

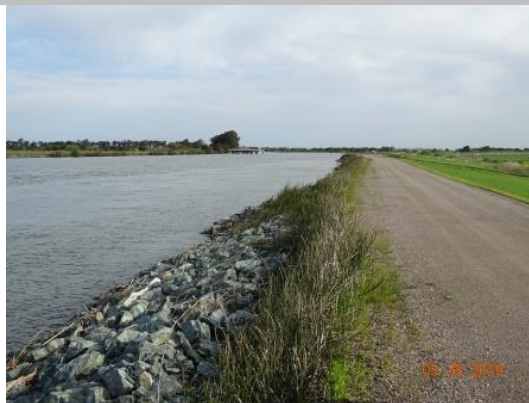
Photo 1 of 1 : SP\_2019\_RD1601\_237\_11\_20190329\_00015.jpg

LM Start	1.00	Rating **	M	Issue No.	11
LM End	1.17	Issue Type +	Ma	Location *	WS
Category	Earthen Levee			GPS Latitude/Longitude	
				Start	End
Item	Vegetation			38.108097 °	38.105757 °
				-121.682807 °	-121.683545 °
DWR ID	DWR_RD1601_01_s_2019_11				
Comment Code					
V1 : Control annual grass and weeds on the levee slopes and easements.					
Inspector Comment

View looking upstream at horsetail vegetation on the waterside shoulder (Spring 2019).

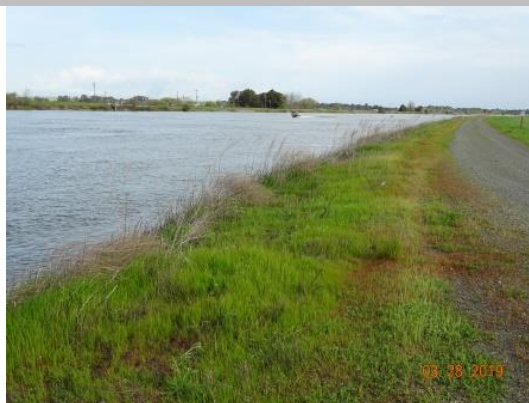
Photo 1 of 1 : SP\_2019\_RD1601\_237\_10\_20190329\_00014.jpg

LM Start	1.17	Rating **	A	Issue No.	10
LM End	2.42	Issue Type +	Ma	Location *	WS
Category	Earthen Levee			GPS Latitude/Longitude	
				Start	End
Item	Vegetation			38.105757 °	38.087735 °
				-121.683545 °	-121.683872 °
DWR ID	DWR_RD1601_01_s_2019_10				
Comment Code					
V1 : Control annual grass and weeds on the levee slopes and easements.					
Inspector Comment					
LMA doing a good job maintaining annual vegetation.

View looking upstream at the annual vegetation on the waterside slope (Spring 2019).
